# The Outdoor Haven Pathway Makeover and Garden Addition

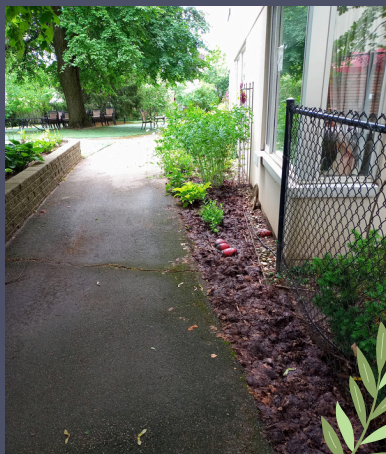
The opportunity to rest comfortably in the dappled shade of an old tree is a rare gift these days. One cannot over-estimate the value of the mature trees in the Outdoor Haven. Yet these same trees were busting the asphalt walking path with their growing root systems, making the entire Outdoor Haven space unusable. Further the artificial grass that made large gatherings possible was in desperate need of renewal because of the same root growth. At Trinity Village we realized we needed to acquire knowledge and understanding of the importance and impact of the Outdoor Haven trees before we could solve the problem that their roots had created along the pathway and across the lawn.

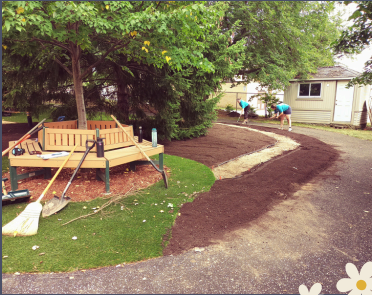
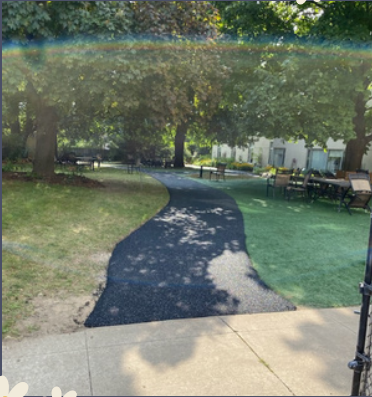
Armed with this new understanding and knowledge, it was a straightforward decision not to remove the decaying asphalt in order to put in a new pathway but to carefully cut around the transacts of root buckling the current pavement, fill the voids with clear gravel, and apply a permeable flexible rubber/granite resin mix on top of the old pavement. This reduced the need to sever large roots (the trees' life blood) to make way for new pavement. It also alleviated the need for large equipment in the area that would further compact the already compacted soil left from the construction of the Care Centre so many years earlier. Compacted soil is a killer of roots. The study further suggested that the size of the artificial lawn could be reduced and concentrated to only those places used during large gatherings. This left a sizeable semi-circle around the Norway Spruce to add another garden for the community to enjoy.
